APOLLO

13's glitch, 14's delay

Human error, not design failure, at fault in the last mission's abort. Nevertheless the next shot faces further postponement

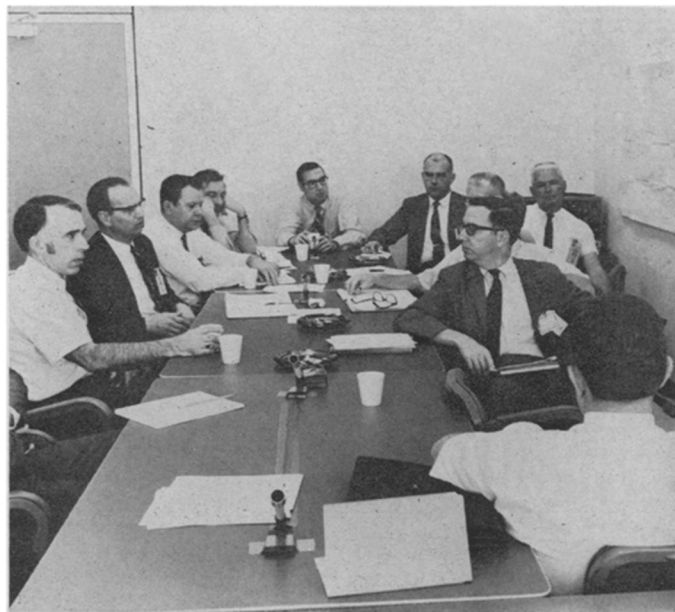
Apollo 13 review board: Human error caused the blast.
