## Research sub trapped; two crew members die of exposure

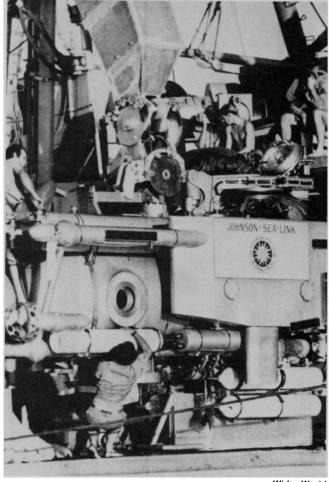
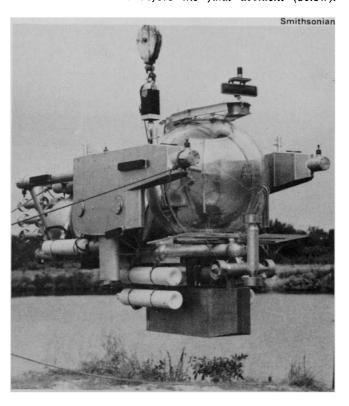
Rescuers gather around the research minisub on the deck of its mother ship, Sea Diver, after its retrieval (above); the Johnson-Sea-Link before the fatal accident (below).
