Lessons Learned From a Lady

The recent Statue of Liberty restoration provided some unique research opportunities

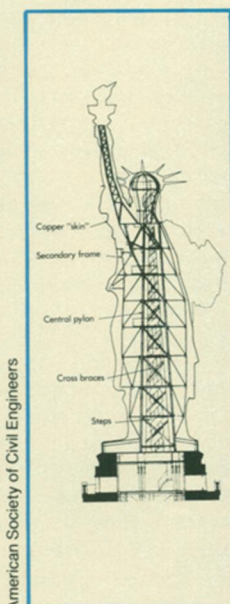
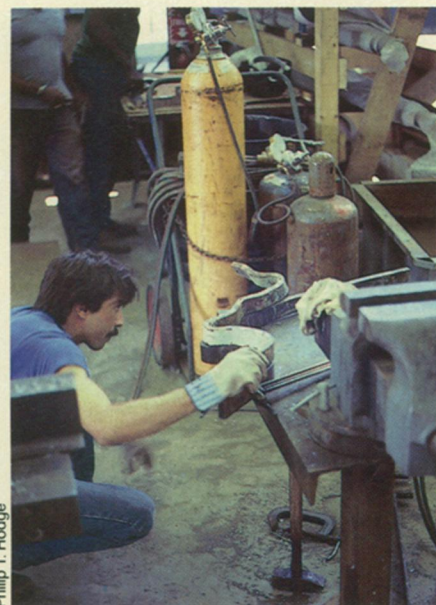
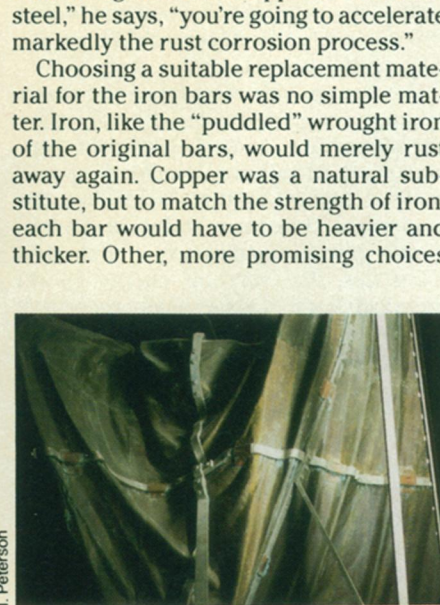
Eiffel recognized that galvanic corrosion — the electrochemical reaction between two dissimilar metals — would be one of the greatest hazards facing Liberty in her marine environment. In the presence of moisture, the combination of iron and copper would act like a battery, and the iron would rapidly rust and eventually disintegrate.

Eiffel tried to solve the problem by inserting an insulating layer of asbestos between the iron ribs and the copper skin. But his solution was ineffective. Because copper is such a good electrical conductor, even a single contact point with iron is enough to spoil the insulating effect. The iron armature system ended up rusting so badly that all the bars had to be replaced during the restoration.

The presence of copper sulfate may have contributed to this corrosion process, says metallurgist Norman Nielsen, a consultant in Wilmington, Del. His tests showed traces of copper and sulfur on the rusted armature bars. "If you pass water containing dissolved copper over iron or steel," he says, "you're going to accelerate markedly the rust corrosion process."

In Eiffel's innovative design, a central pylon with a secondary framework reaches out to the Statue of Liberty's copper skin (left). The copper sheets are attached to iron ribs (right) in such a way that the skin is free to shift slightly. Because of corrosion, the ribs had to be replaced with new stainless steel bars that were shaped to match the contours of the old bars (center).

Choosing a suitable replacement material for the iron bars was no simple matter. Iron, like the "puddled" wrought iron of the original bars, would merely rust away again. Copper was a natural substitute, but to match the strength of iron, each bar would have to be heavier and thicker. Other, more promising choices

In the end, two were chosen. One was ferallium, a high-strength, steel-aluminum alloy used by the British Navy as a bronze substitute. However, because this alloy tends to be springy, metalworkers have difficulty bending it into shape. It was used only for the flexible flat bars that connected the ribs to the iron framework. The alternative, 316L stainless steel, is easier to shape and was used for the armature bars themselves.

Backing tape, consisting of a glass-fiber web coated with Teflon, replaced the asbestos liner between the copper and stainless steel. The tape not only reduces the chance of galvanic corrosion occurring but also works as a lubricant. It allows Liberty's copper skin to slide across the stainless steel without sticking when the statue expands and contracts due to temperature changes during the day.

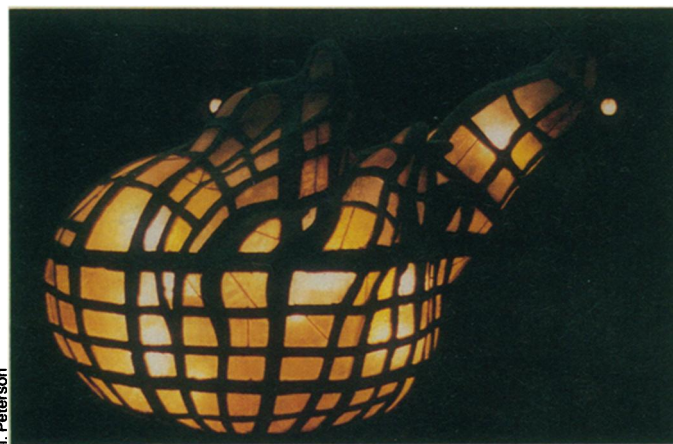
The Statue of Liberty's original torch and flame, shown here, had to be replaced because of extensive corrosion damage. Holes cut into the copper flame to create windows allowed moisture to leak into the statue's arm. The original torch is on display in the museum.

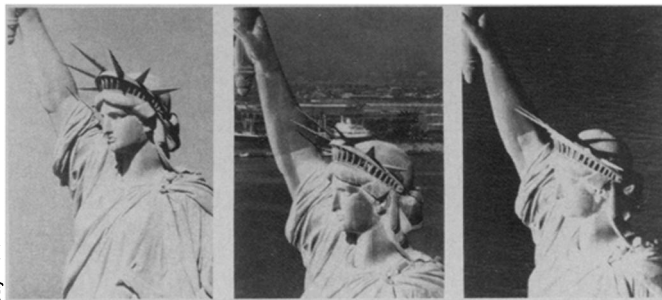
However, sections of the patina itself may be changing. Large areas on the left side of the statue's surface appear to be getting darker, as if the green patina were washing away to reveal the black oxide and sulfide layer underneath. Baboian blames the effect on acid deposition and the severe weather patterns that come from the northeast (SN: 6/29/85, p.404). Other researchers contend that fine, wind-blown sand may be the culprit. Most of the change seems to have occurred since 1965.

Baboian suggests that acid rain could be causing that kind of transformation. As a result, this antlerite-loaded green patina may be washing away, especially in areas exposed to the prevailing winds.

"We took samples of the patina throughout the statue," he says. "One of the interesting effects we saw was that in darkening areas, the green patina had a high antlerite content." Furthermore, other measurements show that the patina is about 10 times thicker in greenish areas than in darker areas.

Curiously, at least one copper sheet, located on the statue's torch-bearing arm, is staying green while its neighbors are darkening. "It must have something to do with the metallurgy of the copper," says Baboian. The unaffected copper seems to be much softer and purer than the darkening copper, he says. Samples from the darkening copper sheets contain large clumps of copper oxide.

That doesn't appear to affect the copper's corrosion rate, says Baboian, but it may affect the copper's surface properties. "A more stable patina forms on the purer copper," he says, "which explains why the panel on the left side of the torch arm has retained its green appearance."

The Statue of Liberty's left side has been getting darker, as shown in these photos taken in 1965 (left), 1974 (center) and 1983 (right). One copper plate on the arm seems to be resisting this change.
