# Saving a stone prayer

**750-year-old York Minster saved from crumbling by new techniques of repair and restoration**

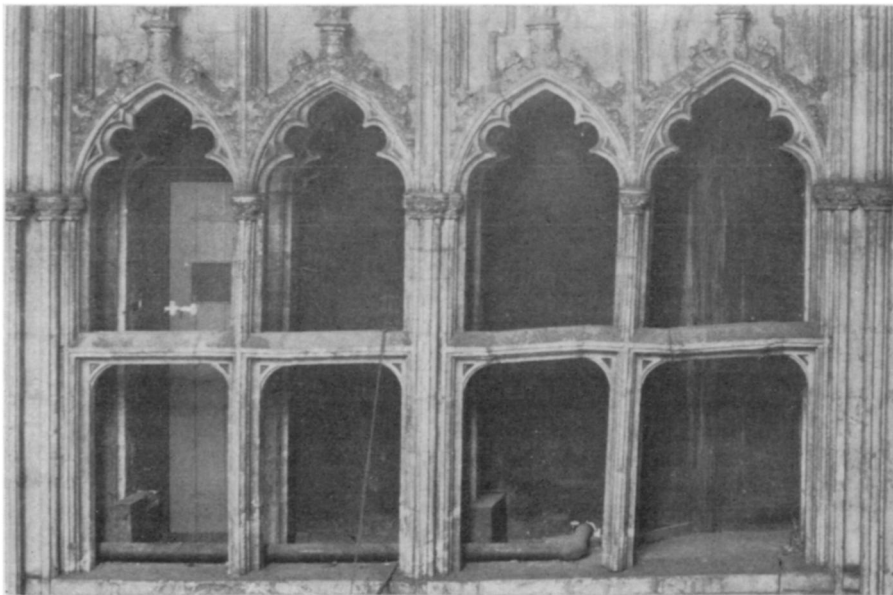
*The sagging cathedral gallery shows the effects of age and poor foundations.*

As a result, engineers estimate that the foundations of York Minster are overloaded by as much as 25,000 tons. Nor does it help any that the original Saxon foundations, upon which everything else has pyramided, consist of masonry supported by timbers that have long since rotted away.

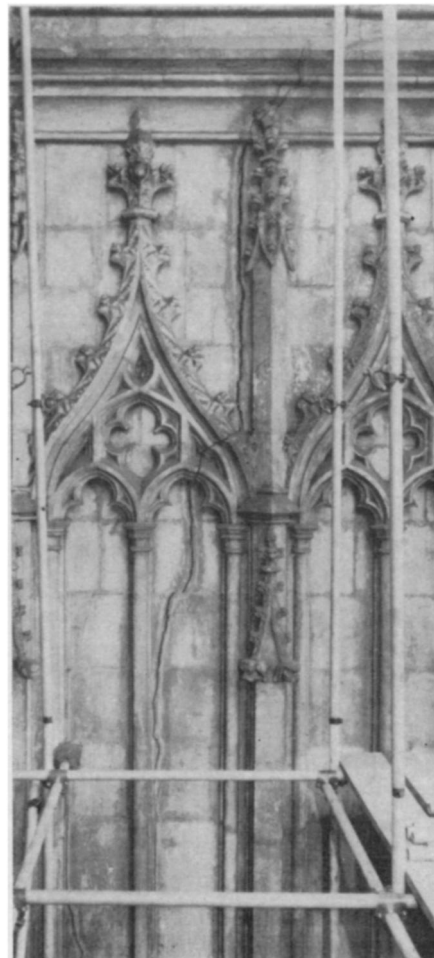
*Crack in a tower wall 120 feet up.*

The inspectors noted that the structure's two west towers, each nearly 200 feet high, had reached so sorry a state that they were literally in danger of crumbling. At the time, engineers put the blame on vibrations caused by the rumbling of nearby heavy traffic; High Petergate, a main traffic artery, passes only 50 yards from the west end of the

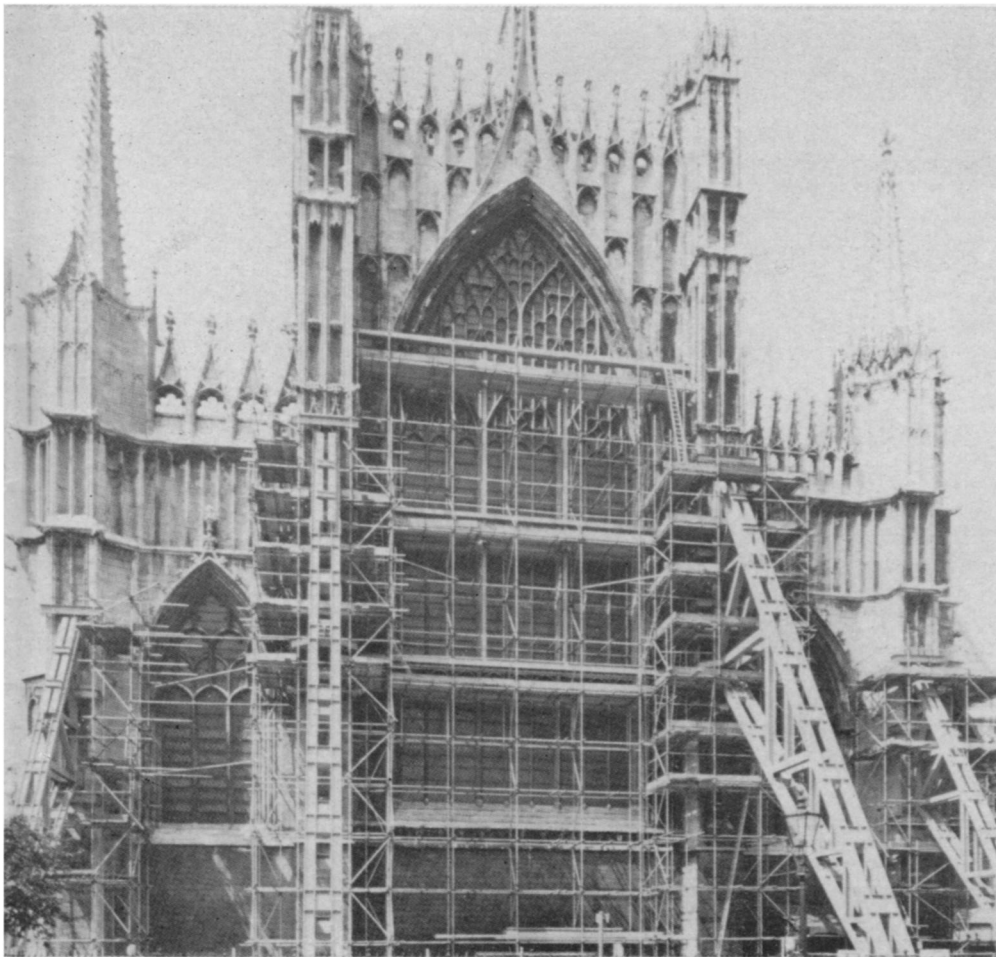
*Swathed in I-beams and scaffolding, York Minster's east front awaits repair.*

tion might crack the precious panes. Heavy panels of translucent plastic and braces of heavy timber were placed inside and outside to protect them.
