Lessons Learned From a Lady

The recent Statue of Liberty restoration provided some unique research opportunities

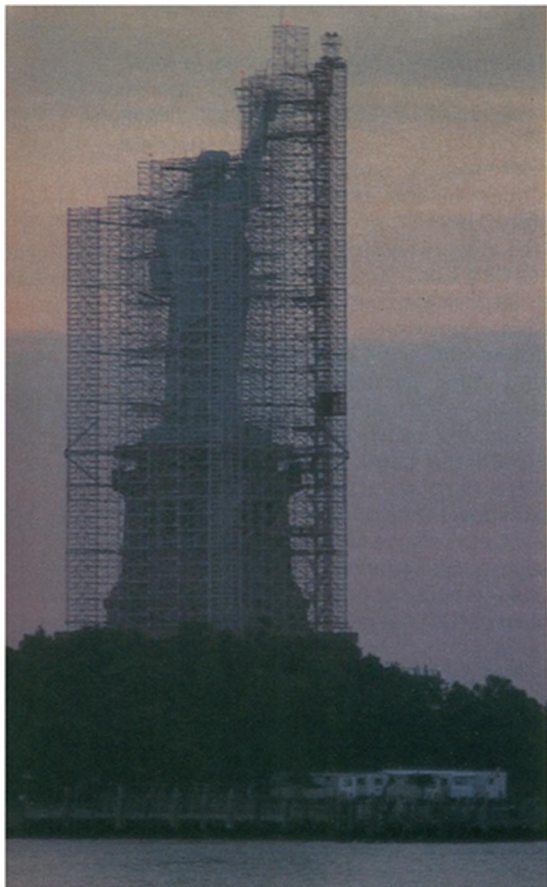
While the restoration was going on, a special aluminum scaffolding enveloped the statue.

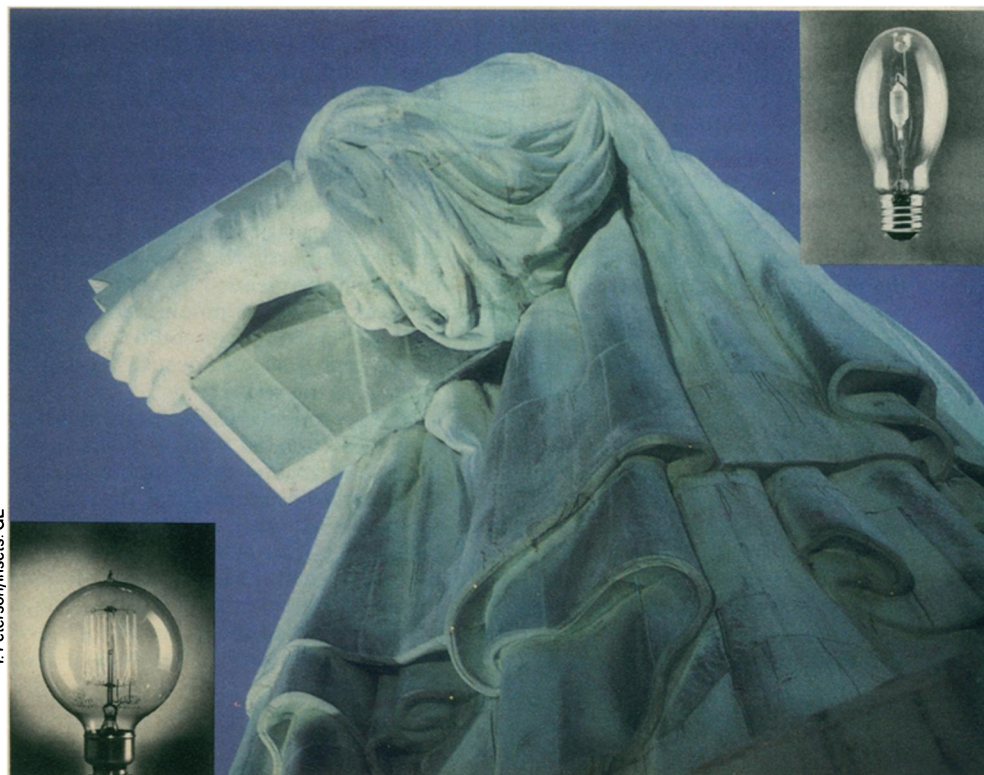
The new Statue of Liberty lighting scheme is designed to capture the quality of natural daylight. Researchers had to invent two new metal-halide lamps (upper right) to provide the right colors. The original 1916 lighting scheme used 246 bulbs (lower left); the new one uses only 42.
