## **Eyes on Venus: A new dimension**

## Enduring the hot, dense atmosphere of Venus, a Soviet spacecraft has provided the first look at the planet's surface in color

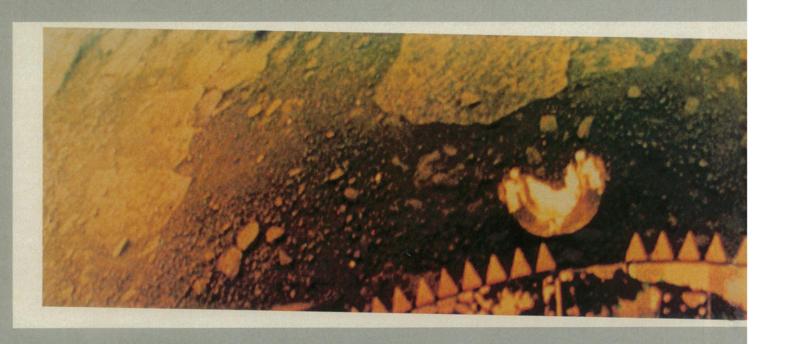
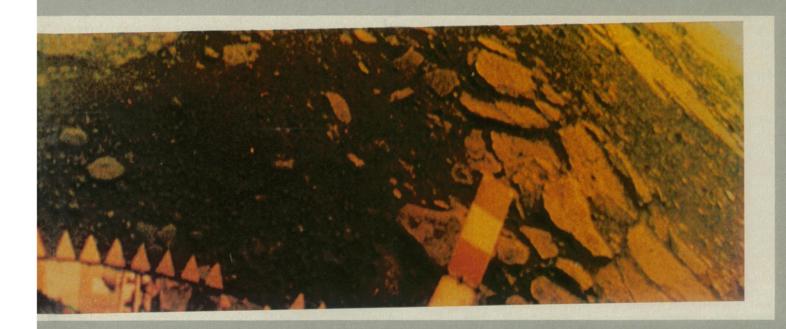
The sole example, shown above, was taken by Venera 13 only minutes after its March 1 landing on Venus at 7°30′S by 303°, just east of a region known as Phoebe (see cover). The image is still in preliminary form, and like the black-and-white photos it still shows the geometric distortion caused by the oblique, wide-angle close-up. This is expected to be corrected in processing, transforming the frame into a cup-like shape.

balance. The checked strip at right is a color-test chart, which, says Harold Masursky of the U.S. Geological Survey, probably includes what under earthly lighting would be shades of blue and green as well as the apparent red-orange hues. The Soviets have reported that the planet's sky is "orange," as seems to show in light reflected from the spacecraft's landing ring in the foreground. (The jagged "teeth" around the ring are "spoilers," designed to keep the lander from swinging as it hung from its parachute lines during its descent. Several years ago, the Soviets provided the U.S. Viking project with data on such descentaerodynamics, based on experience with Soviet Mars landers in the early 1970s. The other piece of hardware in the color Venera photo, just left of center, is the jettisoned protective cover for the camera's viewing window.) James Pollack of the NASA Ames Research Center has suggested that an orange-ish sky over Venus would not be unexpected, since the dense atmosphere would distort and absorb the blue wavelengths of incoming sunlight. What appear to be patches of sky at the photo's upper corners show only a pale orange tint, but this could be due to lighting and exposure effects.

The brownish hue of the surface, while it could be that of a gray-black terrain (like that of earth's moon) seen through the Venus atmosphere, is what some researchers would expect to result from highly oxidized material. The color of Mars, for example, is essentially that of rust - oxidized iron. (The similar though paler color of the Martian sky—a much thinner and thus less blue-absorbing atmosphere than that of Venus — has been attributed to suspended particles of surface dust.) Free oxygen is almost non-existent in the Venus atmosphere, but recent analysis of deuterium:hydrogen measurements from the U.S. Pioneer Venus mission has indicated to the University of Michigan's Thomas M. Donahue and colleagues that the planet once had a veritable ocean's worth of water (SN: 12/12/81, p. 372). The water would have long since dissociated in the heat, letting its hydrogen escape into space, but the heavier oxygen could have stayed behind to oxidize the crust. Furthermore, notes Jeffrey L. Warner of the NASA Johnson Space Center, although the present Venus atmosphere has a far smaller percentage of water than earth's, it also has a far greater total pressure, so that the partial pressure of water on the two planets is about the same. The fact that Venus is also hotter than earth by more than  $400^{\circ}\text{C}$ , he says, means that water there has a greater "activity," or potential for such reactions as oxidation and erosion.

The overall appearance of the scene, says Masursky, "fits perfectly" with expectations based on earlier studies. Radar maps from the Pioneer Venus orbiter and from the Arecibo and Goldstone on earth showed the topography and roughness of the region (and indeed of much of the planet) to be typical of basaltic lava flows. Soviet analyses of X-ray fluorescence spectroscopy conducted by both Veneras 13 and 14 indicate the presence of tholeitic basalt, "the commonest kind on earth and the moon." Such basalts, he says, often form in layered flows, and U.S. and Soviet researchers alike have noted the layered appearance of the landing sites. Also typical of such floodlike "effusive" flows is the lack of large vesicles, or remanent gas bubbles, such as might have powered more explosive eruptions.

Both of the Venera 13 photos show abundant small particles on the surface (the Venera 14 site appears much "cleaner"), and scientists have suggested that physical and chemical erosion could be particularly active on Venus. Winds near the surface are slow, however, and James Garvin of Brown University points out the lack of "wind tails" — accumulations of fine particles on the lee sides of the larger chunks. On the other hand, some observers have said that the "fines" appear concentrated around the lander, as though they were formed by the spacecraft's impact, so that there might simply have been no time for wind tails to form.
